**Part No.      ALL72150  
                     ALL72152**

## **Tail Shaft Seal And Bushing**

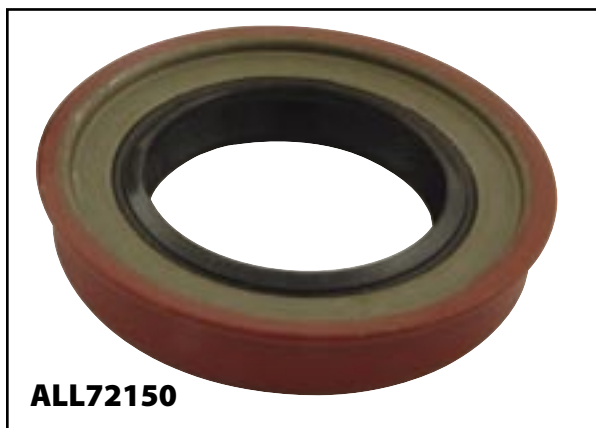
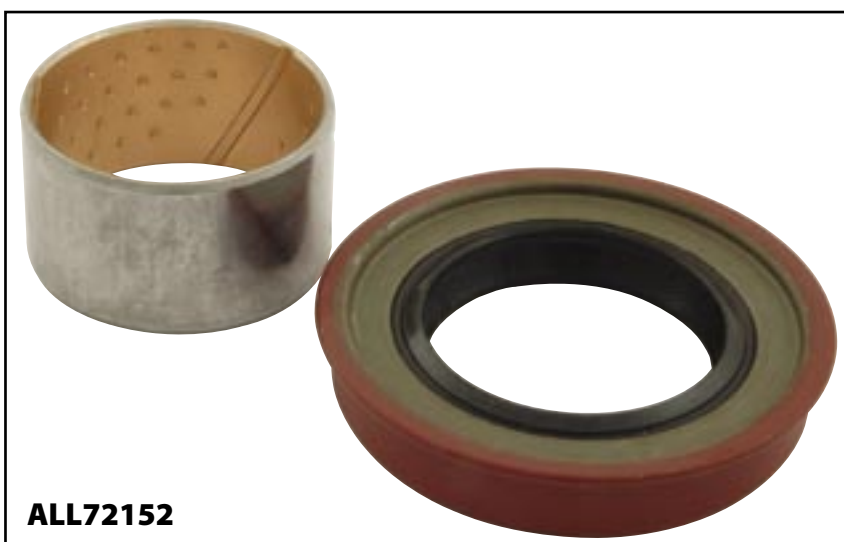
The tail shaft bushing is a regular wear item, located inside the transmission tailshaft housing. It should be replaced when replacing a tailshaft seal or when a driveshaft failure has occurred. A worn bushing will cause excessive side-to-side movement of the slip yoke and create a vibration or leak. Bushing and seal fit GM Powerglide, Turbo 350, Saginaw, Muncie, Bert and Brinn transmissions.

ALL72150.....Seal

ALL72152.....Seal With Bushing
